**PRIOR RECLAMATION INSPECTION REPORT
AND
RECOMMENDATION FOR RELEASE OR PERMIT
REQUIREMENT**

United Nuclear Corporation - Anna Lee Mine

**New Mexico Energy, Minerals and Natural Resources Department
Mining and Minerals Division
Mining Act Reclamation Bureau**

August 3, 1995

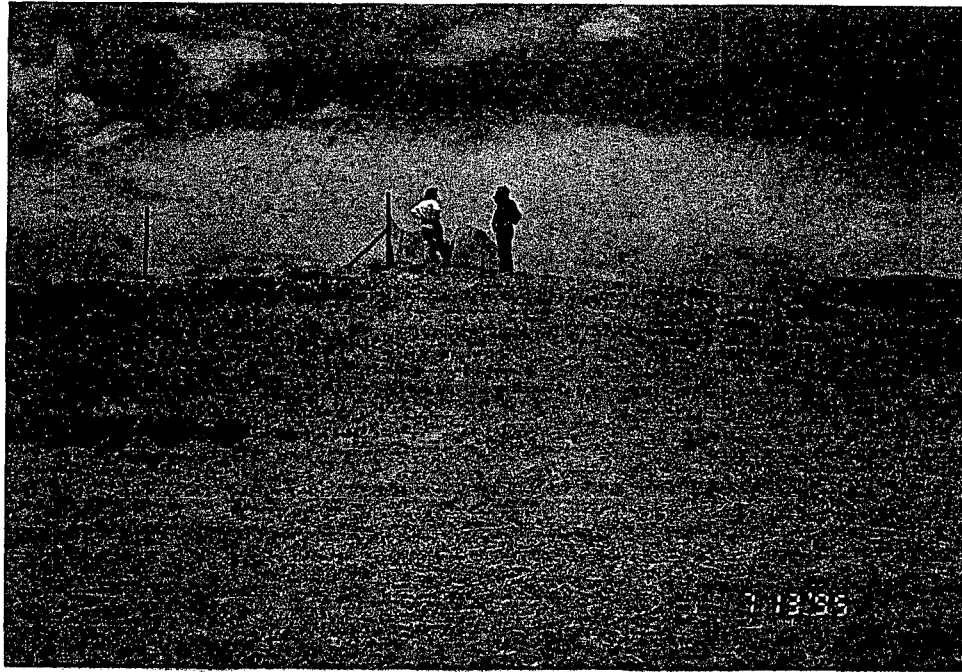
Photo 1. Site Mound from east, 20 yards from site

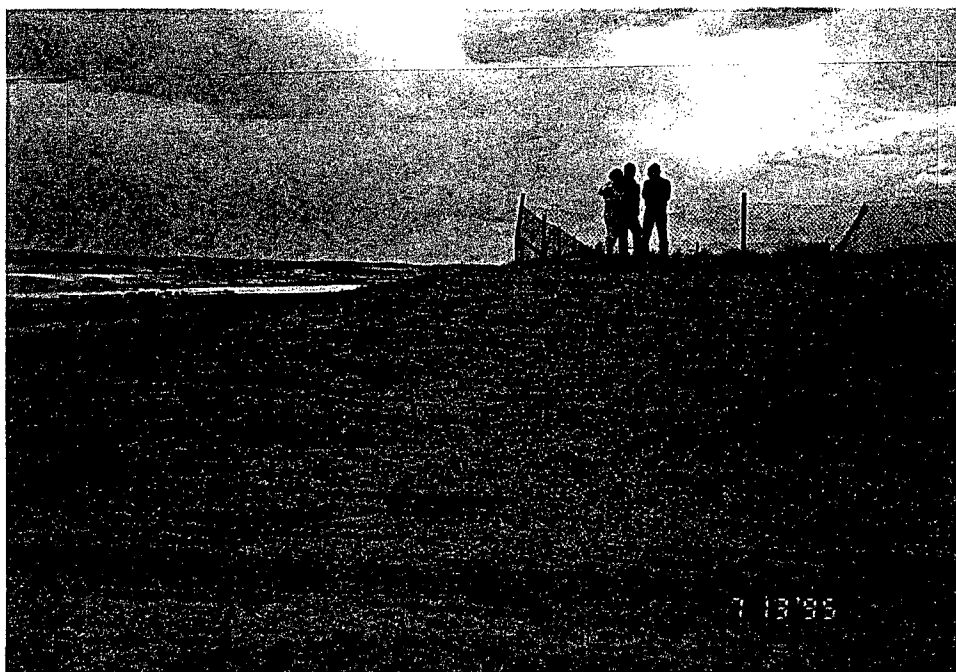
Photo 2. Site Mound from south, 20 yards from site

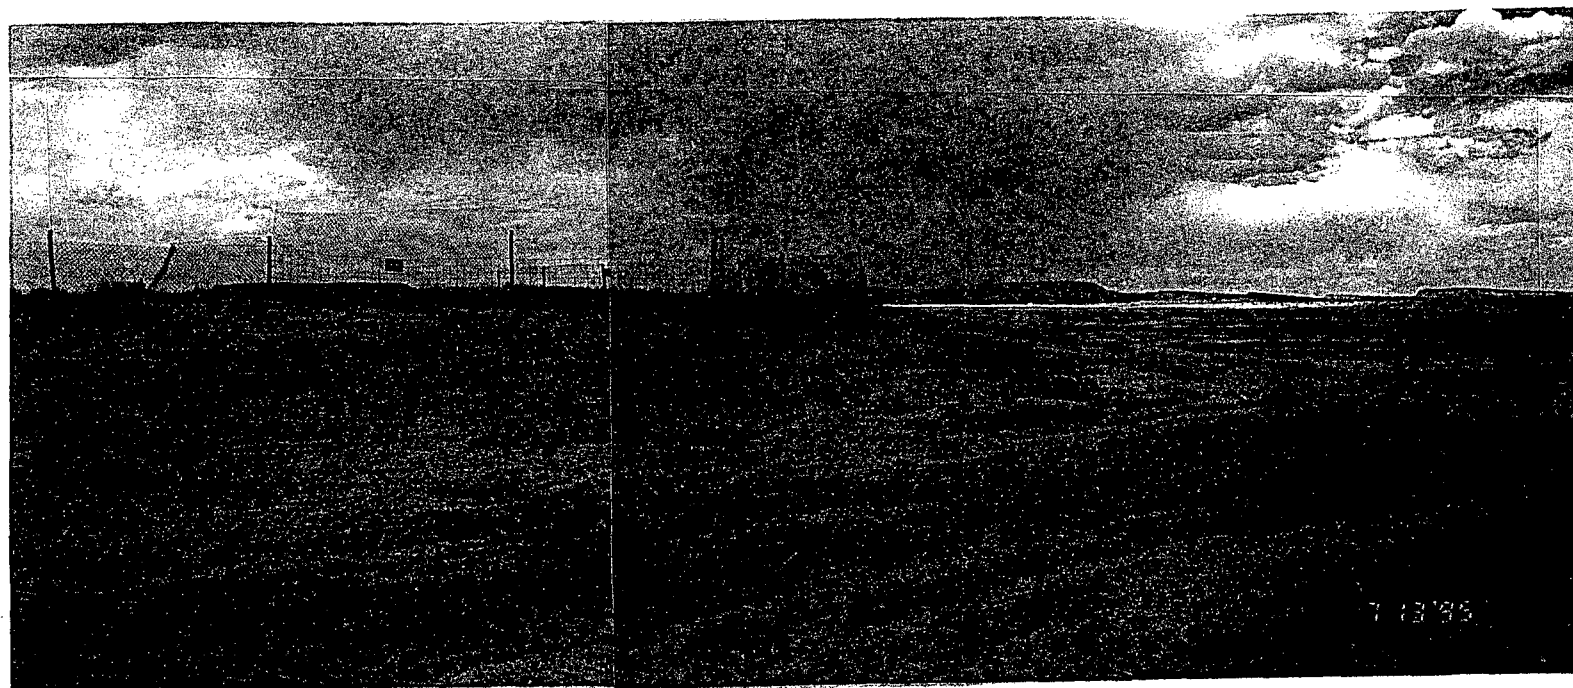
Figure 5&6. Side slope of site from east
